Summary

Dogwood Trail Tree Strike Facilitated Learning Analysis

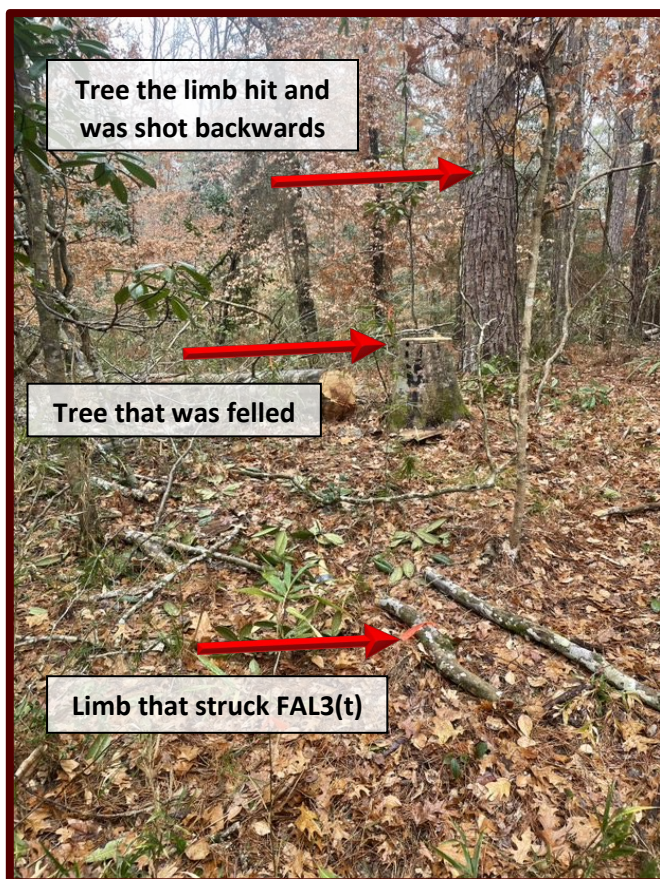
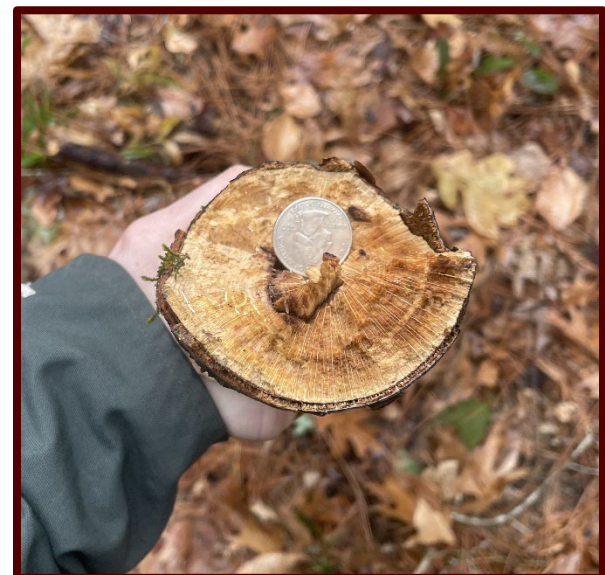
Quarter placed on the end of the limb that struck FAL3(t) to show size/scale

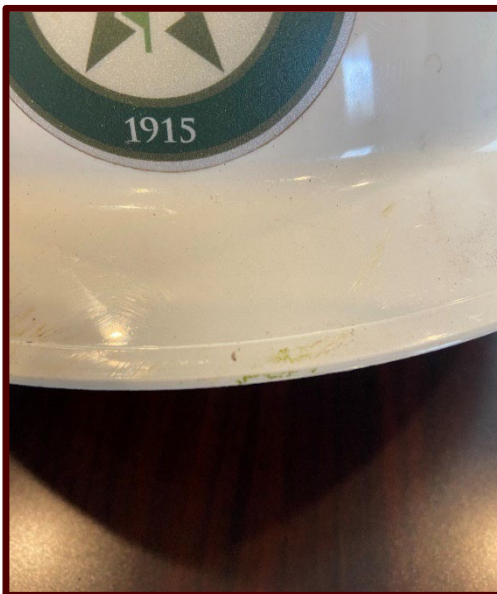
Smudge where limb impacted FAL3 Trainee's hard hat and knocked it off his head

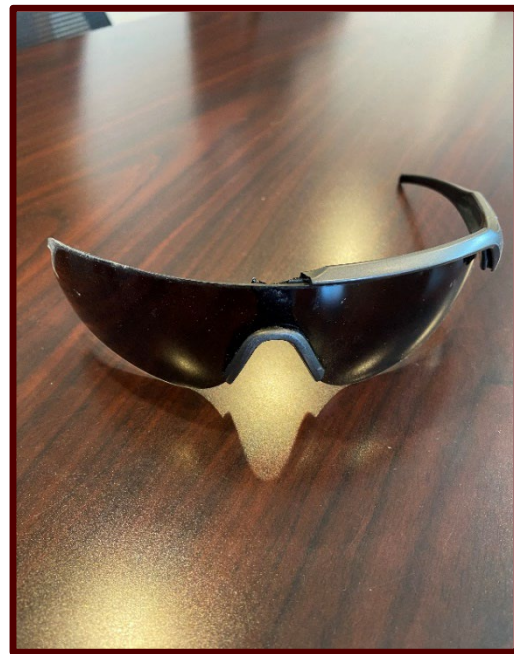
Damaged safety glasses worn by FAL3 Trainee
