# Rapid Lesson Sharing

**Event Type:** Bulldozer Low Water Crossing Submersion

**Date:** April 6, 2022

**Location:** Sand Creek Fire,  
Amarillo, Texas

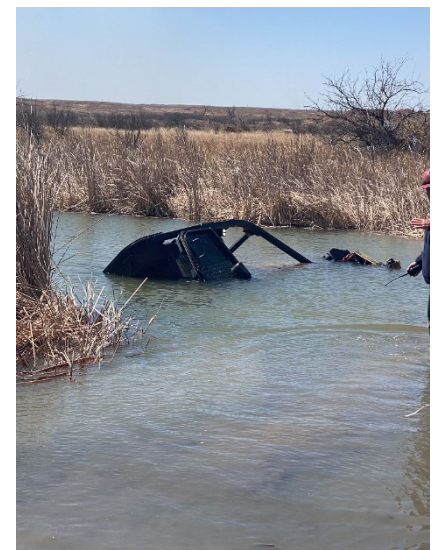
**The dozer submerged in the water after the “rip-rap” gave way.**

1. **When crossing near or over areas of water with the potential for the equipment to become submerged, keep the doors open and your seatbelt on.** The doors are extremely heavy, and if they are closed when you become submerged, they will be nearly impossible to open—just as they were in this incident. Even in normal conditions, when on a moderate angle, the bulldozer doors are cumbersome and hard to open due to their heavy weight. You should not take your seatbelt off, as it will keep you oriented and safer when the dozer rolls or slides into the water.

2. **Always have a designated swamper or spotter when operating in adverse terrain or near water.** You will need this extra set of hands and eyes to spot risks. If a dozer becomes submerged with the door closed, an extra person is needed to help open the heavy doors due to the added suction of the water.

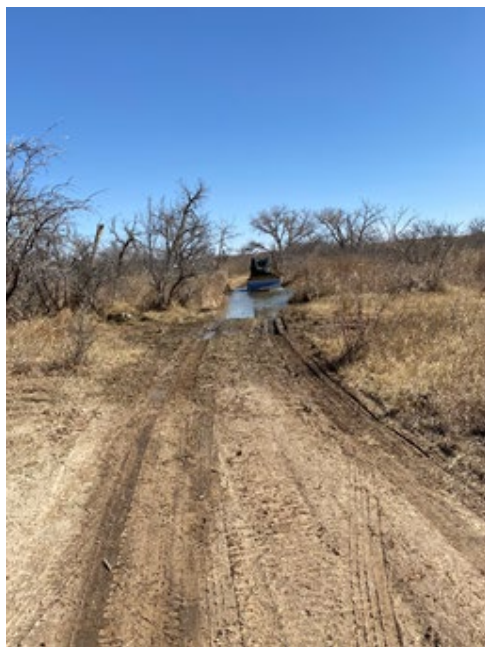
**Image shows the vehicle tracks at the “rip-rap” low water crossing. In the distance, the dozer can be seen starting to cross the waterway.**

A private landowner had placed a concrete “rip-rap” crossover, which previous vehicle traffic had used to access the area across a drainage. (Rip-rap is human-placed material used to protect streambeds and shorelines from wave damage and erosion). The TFLD(t), who was a Heavy Equipment Boss, walked across the drainage and found the concrete sturdy. It appeared to be between eight to ten feet wide, with the water level at shin-deep across the filled-in area.

There were also previous vehicle tracks, indicating the rip-rap concrete that was pushed in by the landowner had been solid enough for heavy equipment to cross. As the TFLD(t) walked across the rip-rap, the shin-high water was still and clear. There were no concerns about the dozer’s

3. **When crossing areas with unknown water depth on the sides of the travel path, mark the edges with flagging.** Although the TFLD(t) was guiding the dozer across the low water crossing, had the route been marked with flagging, this would have provided the operator a visual path to follow.

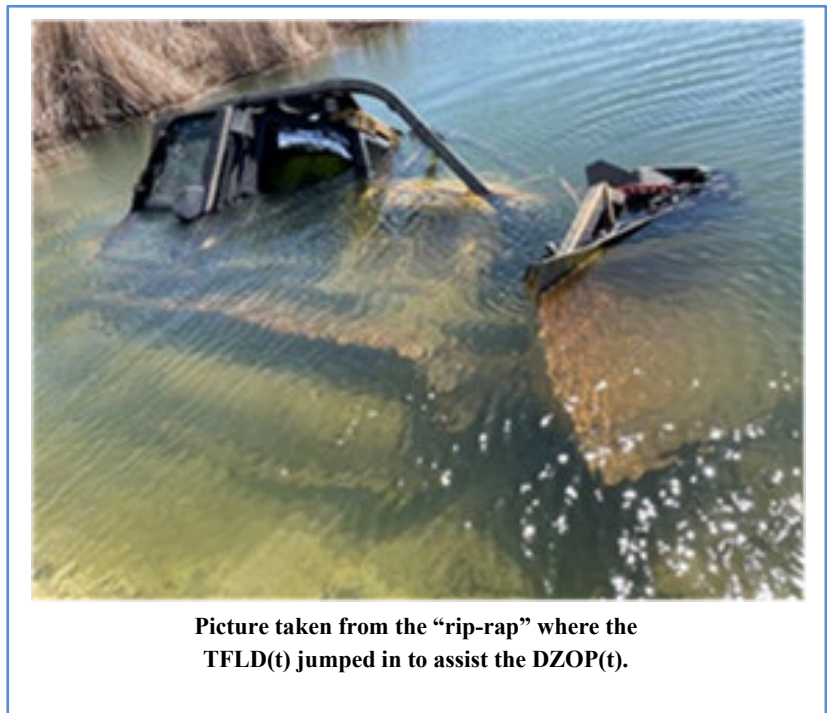
Picture taken from the “rip-rap” where the TFLD(t) jumped in to assist the DZOP(t).
